## 20 Year SolarEx Silicone Restoration System

2.5 GAL Silicone/SQ – 1.0 GAL Acrylic Primer/SQ

Silicone Mastic All Details & Penetrations on Built-Up Roofing Cap Sheet

15,000 sq ft Commercial Building - Corona CA 92879

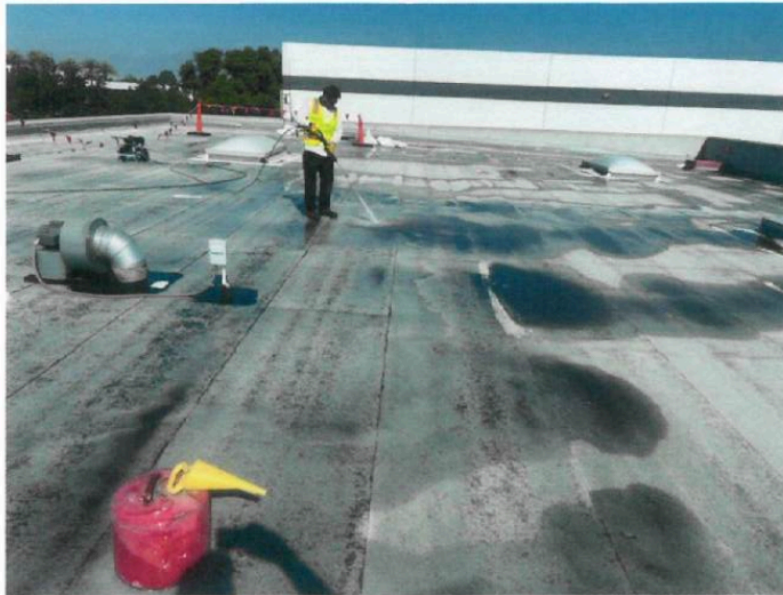
First day on the job we clean, and power wash the existing roof system.

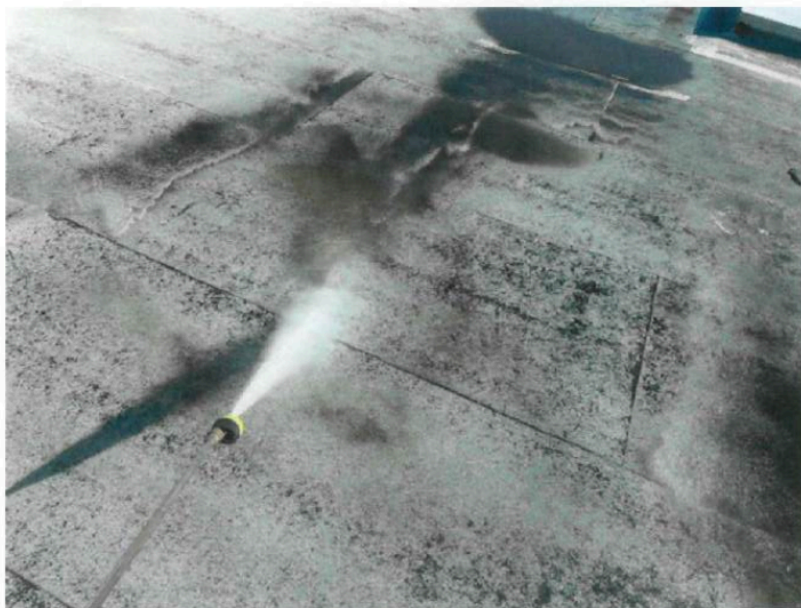
All dirt and loose granules must be removed to get the proper adhesion.

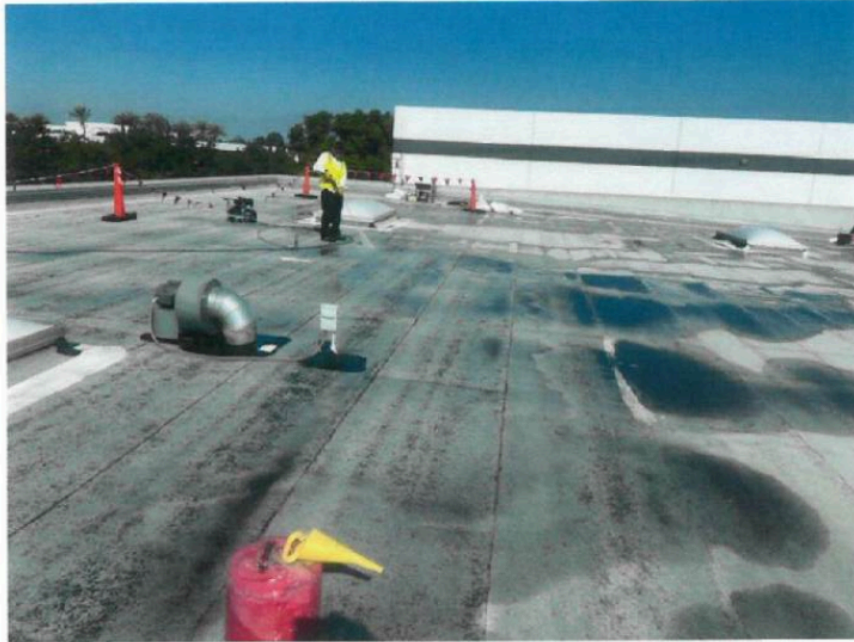
All dirt and debris is being washed from the roof.

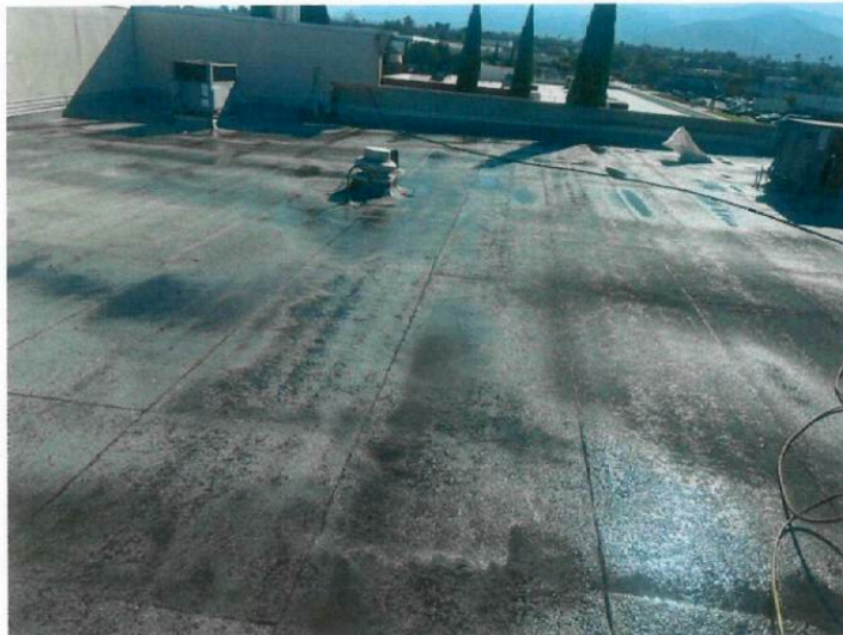
Once completely dried we can start applying the bleed block primer.

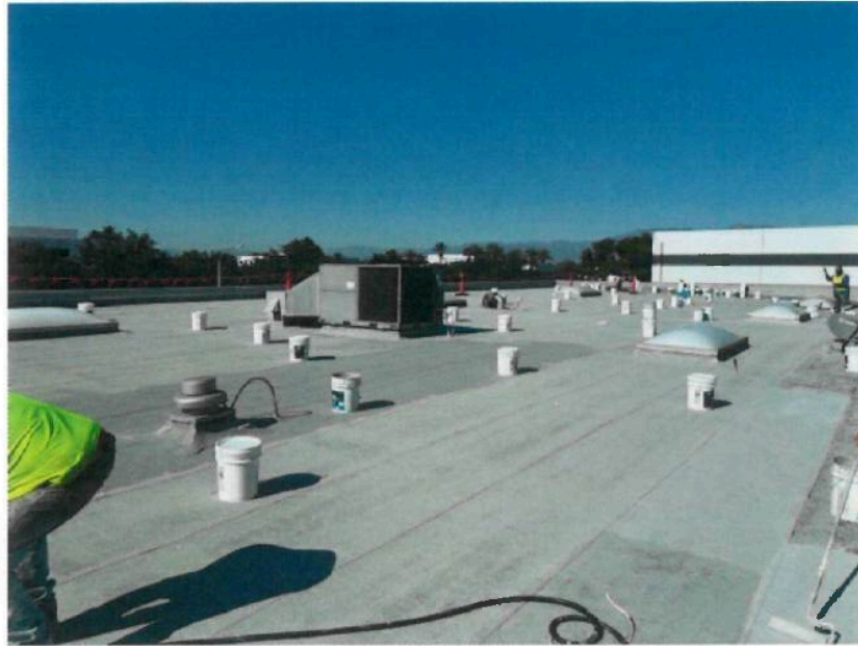
Applying the bleed block primer at a rate of one gallon per every  
100 square feet.

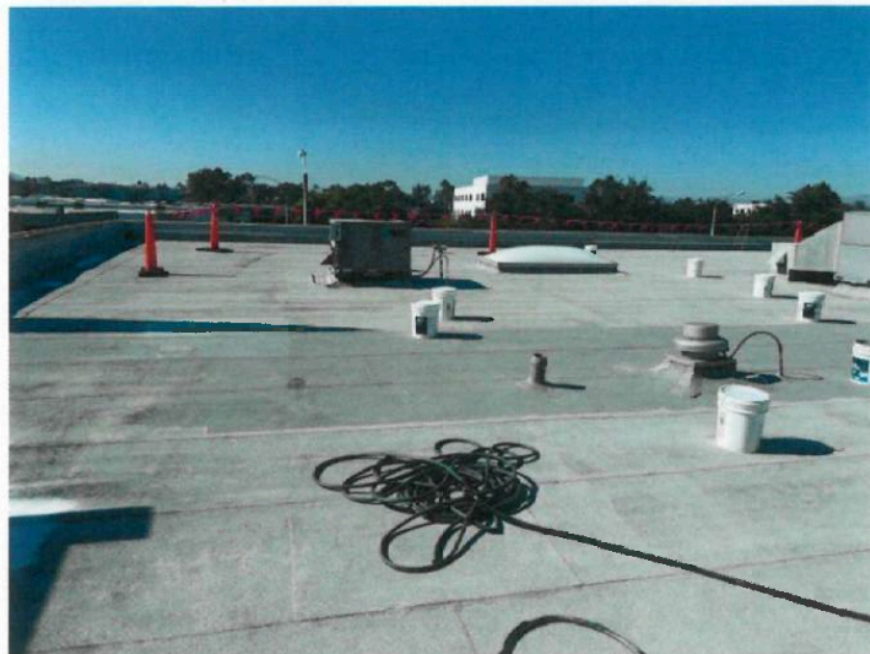
The roof system is being primed and made ready for the repairs.

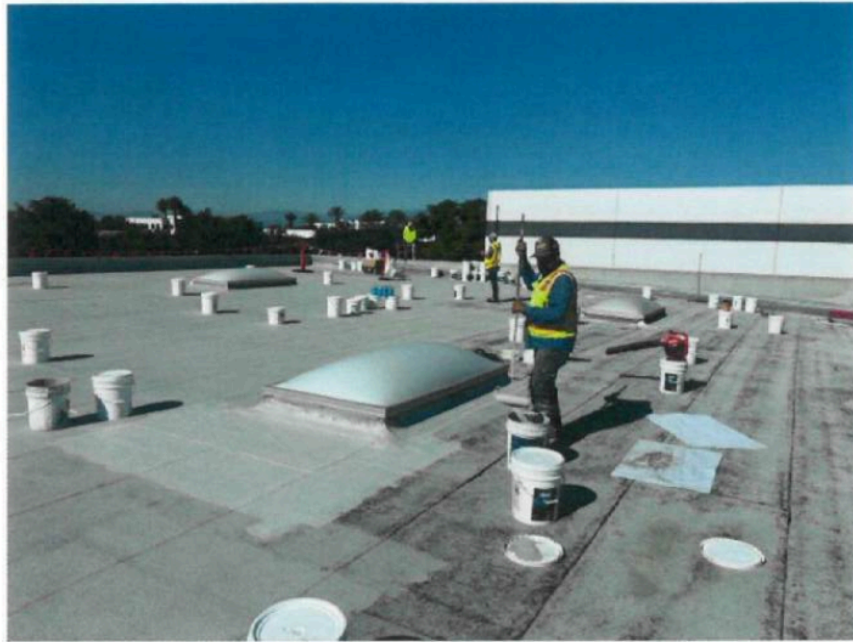
Once the primer is completed we will start applying the Silicone mastic to all penetrations on the roof.

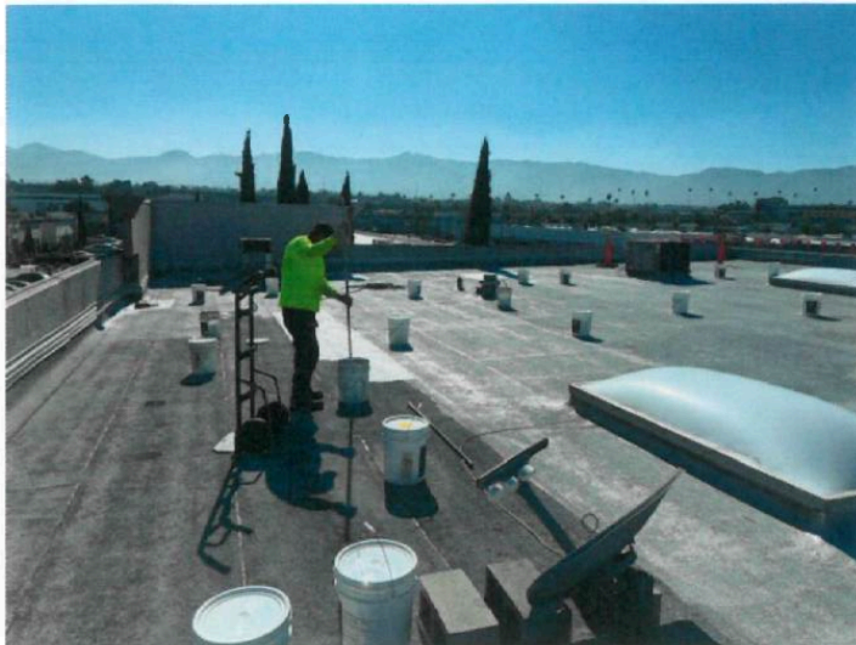
Exiting roof system will be completely primed by the end of the day.

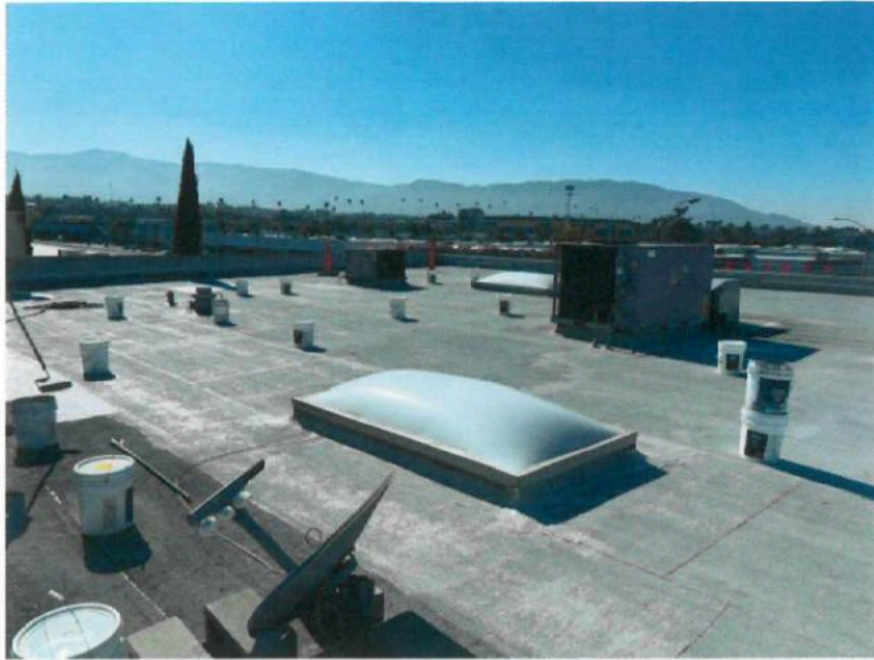
Existing roof system is almost completely primed.

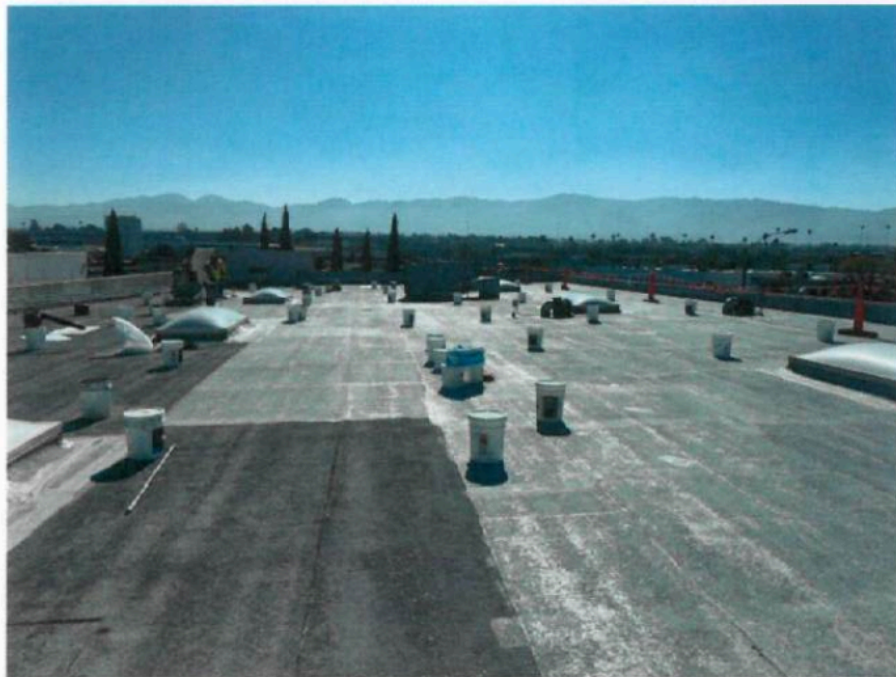
Once primed we will start the Silicone mastic.

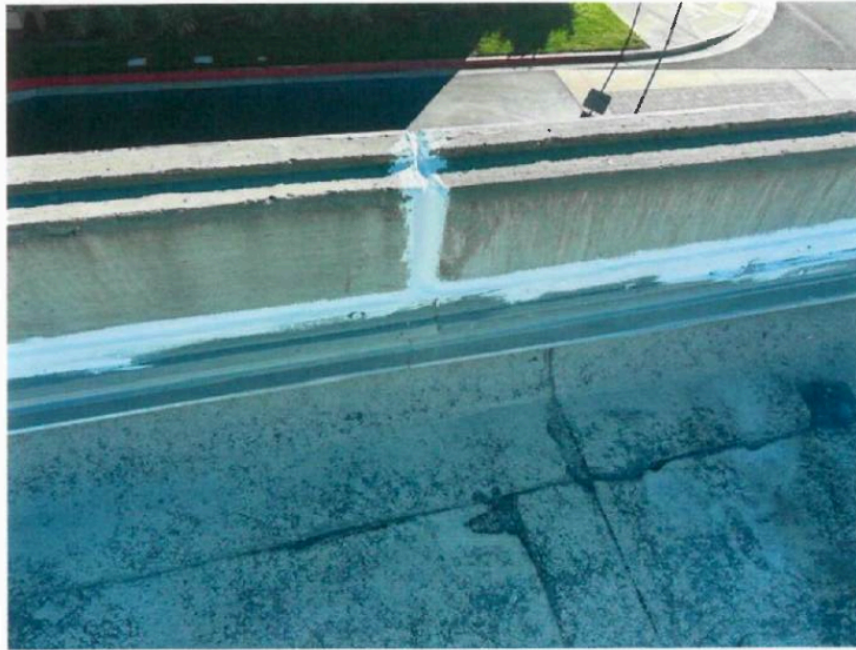
All expansion joints in the parapet walls are being resealed using Silicone mastic. Top of sheet metal reglet flashing is also being sealed.

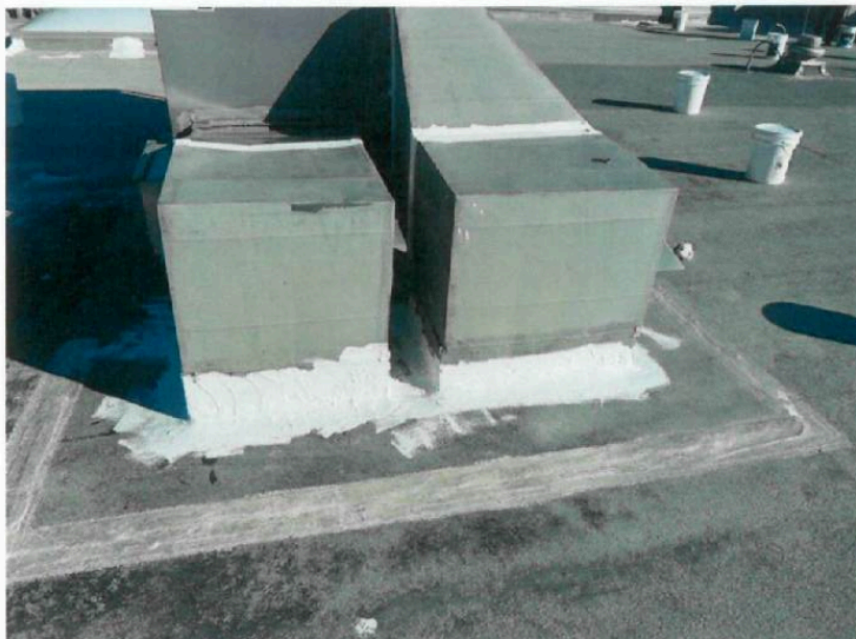
All duct work shall be resealed, primed, and coated with Silicone.

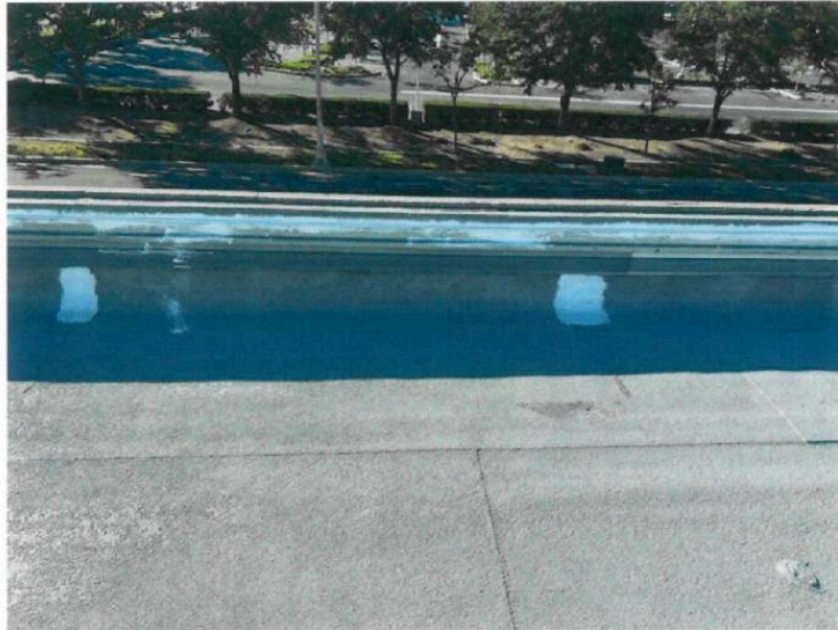
All vertical laps on the walls are prob and reinforced as needed  
using Silicone Mastic.

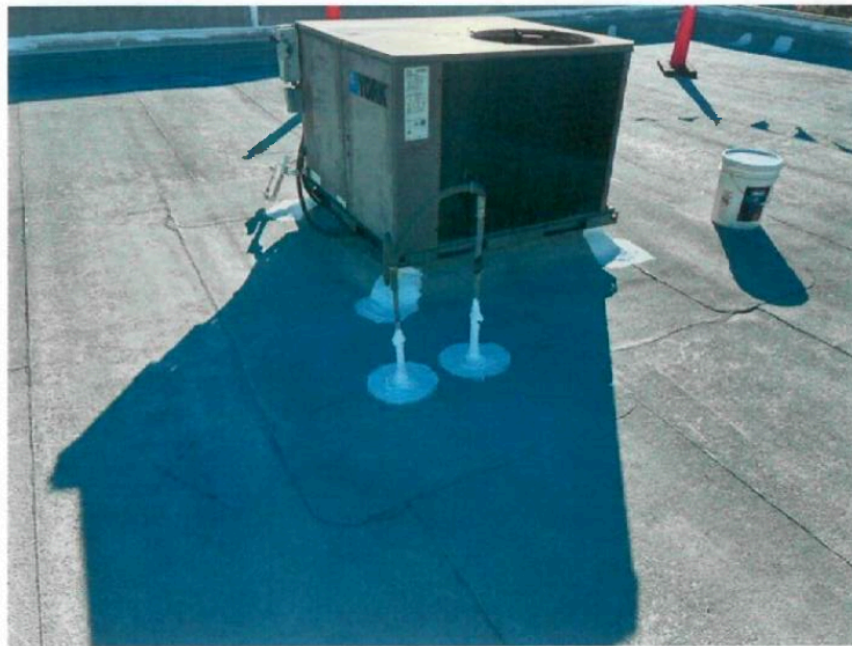
All corners and pipe penetrations are being sealed using Silicone  
Mastic.

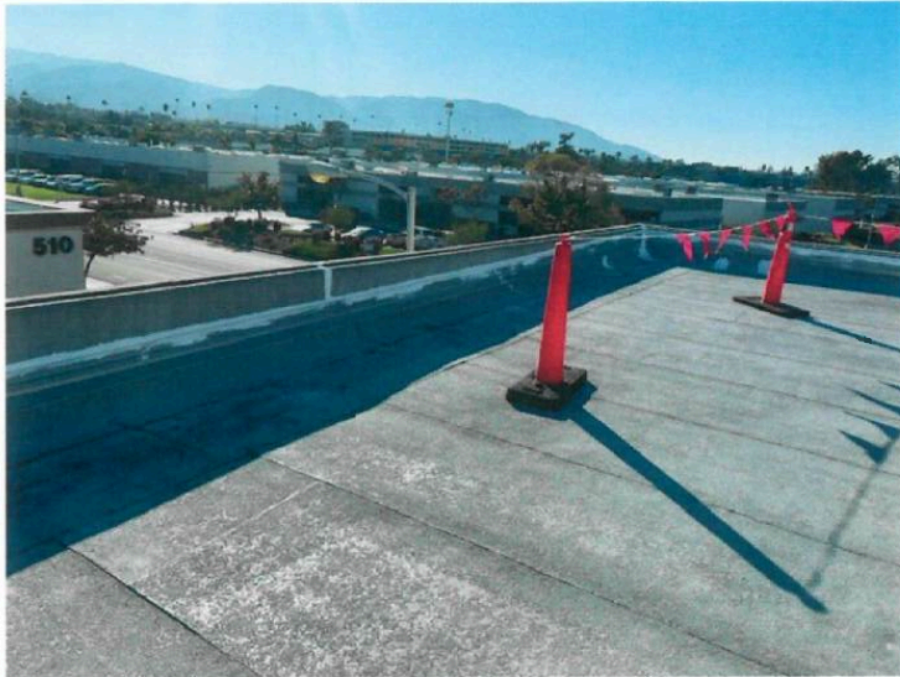
Expansion joints and sheet metal counter flashing is being reinforced with Silicone mastic.

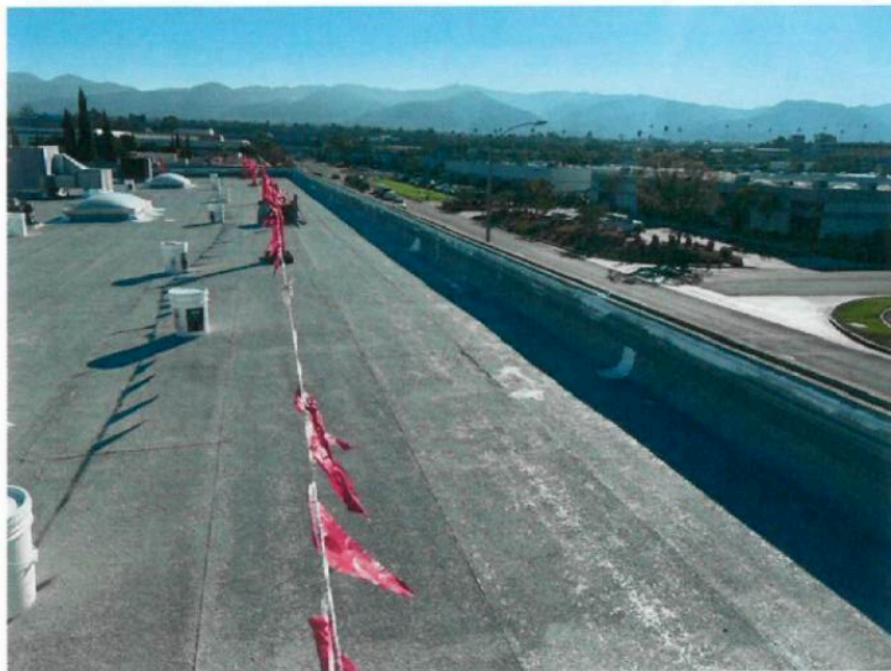
This section of the roof is now ready for Silicone coating.

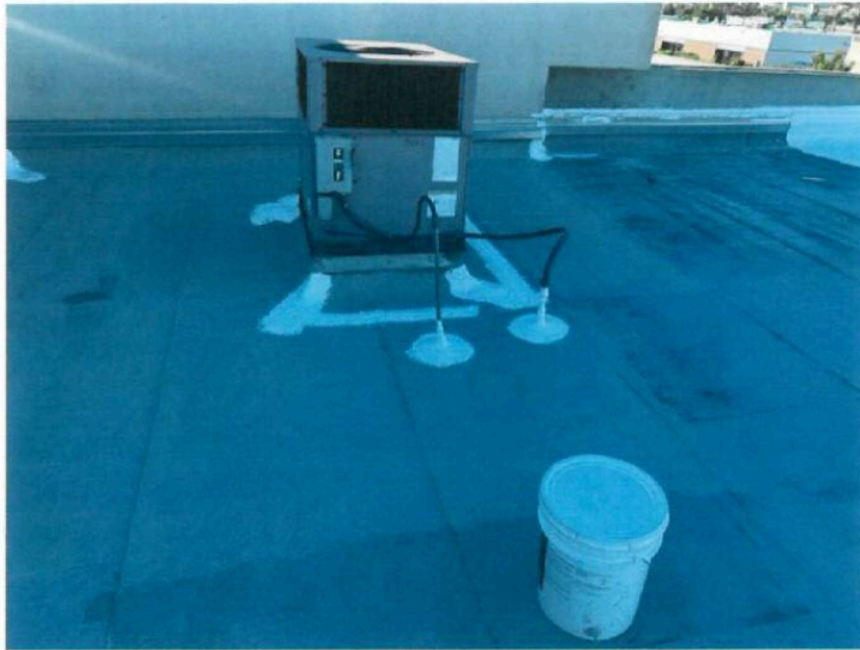
All curbs and penetrations have been reinforced using Silicone Mastic.

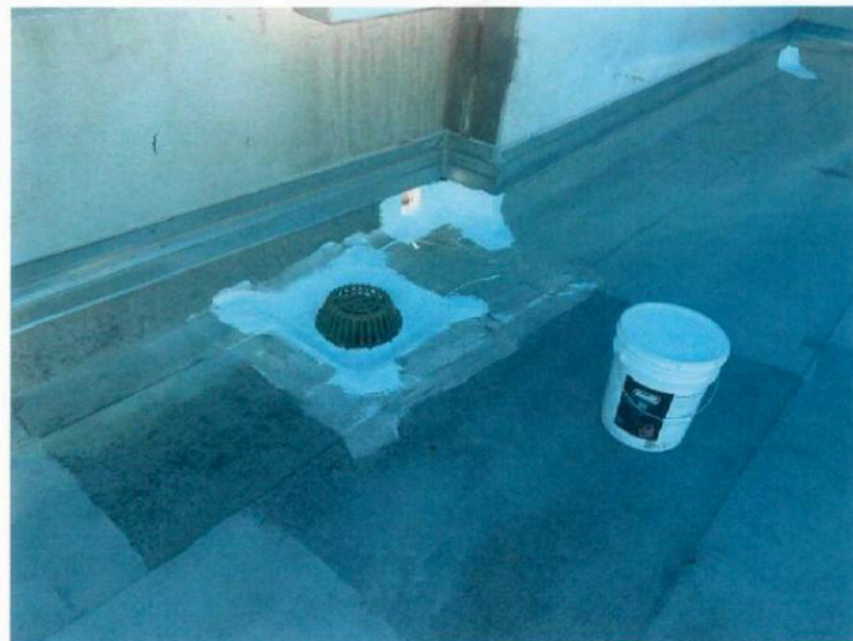
All drains and through wall scuppers have been resealed & reinforced using Silicone mastic.

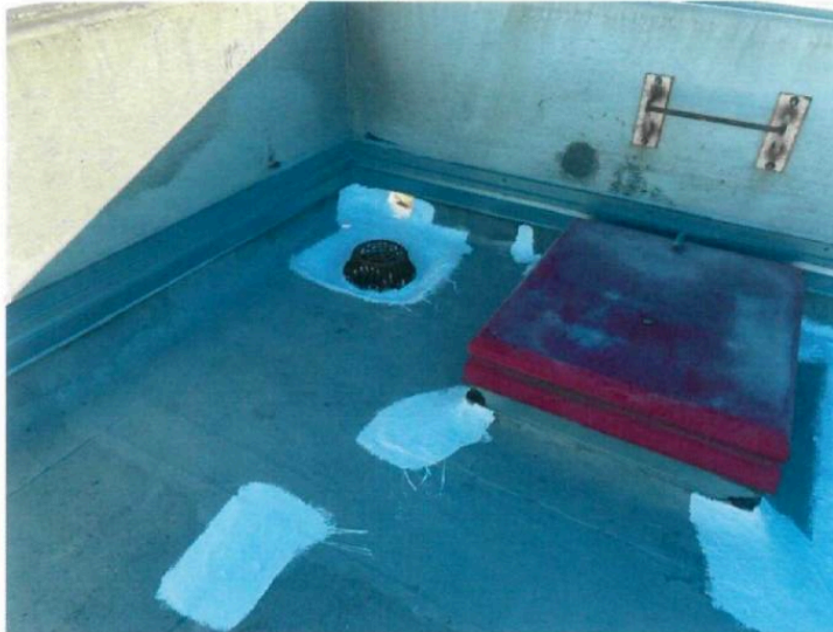
Corners of the roof hatch has been properly sealed with Silicone mastic.

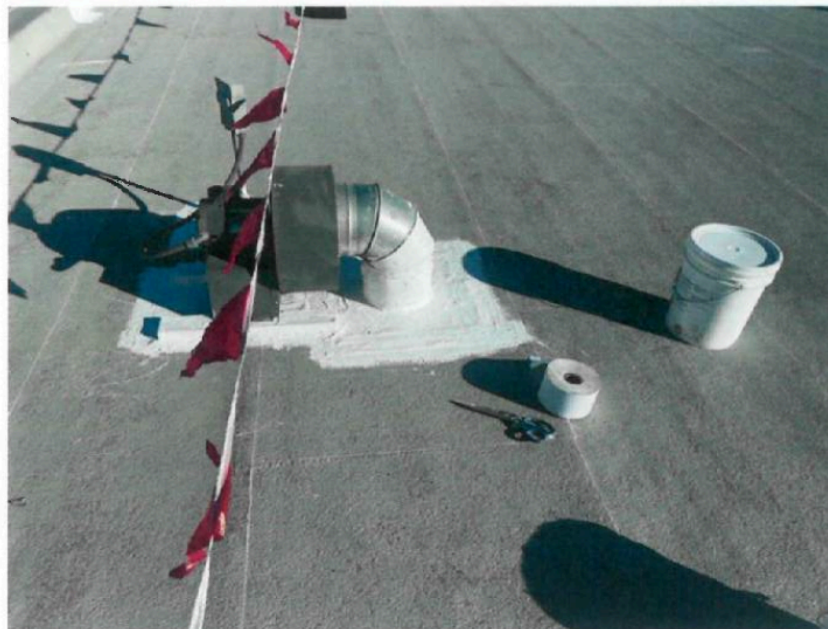
Small units have been resealed and reinforced using a three-course flashing.

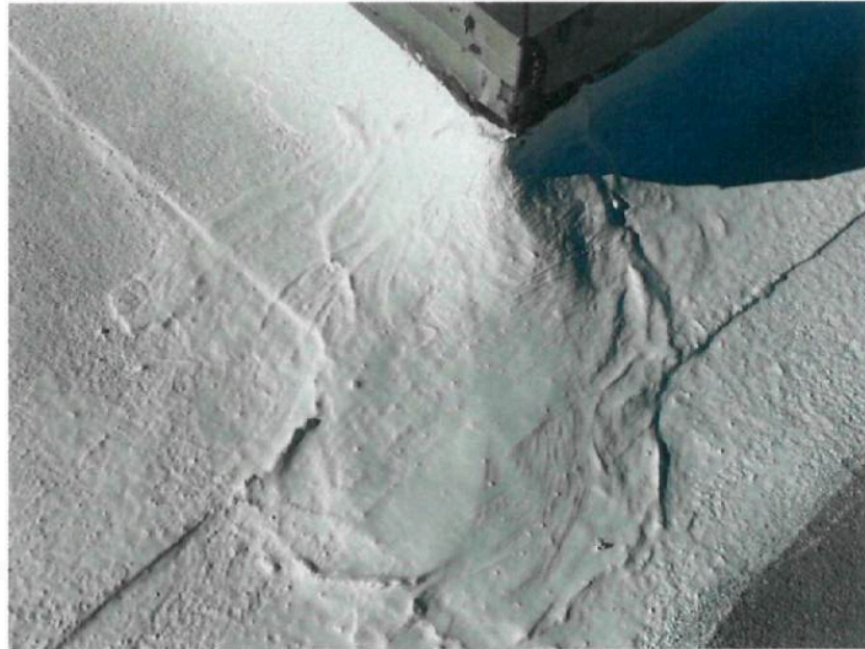
Corners of all skylight curbs have been cleaned, primed sealed  
with Silicone mastic and coated.

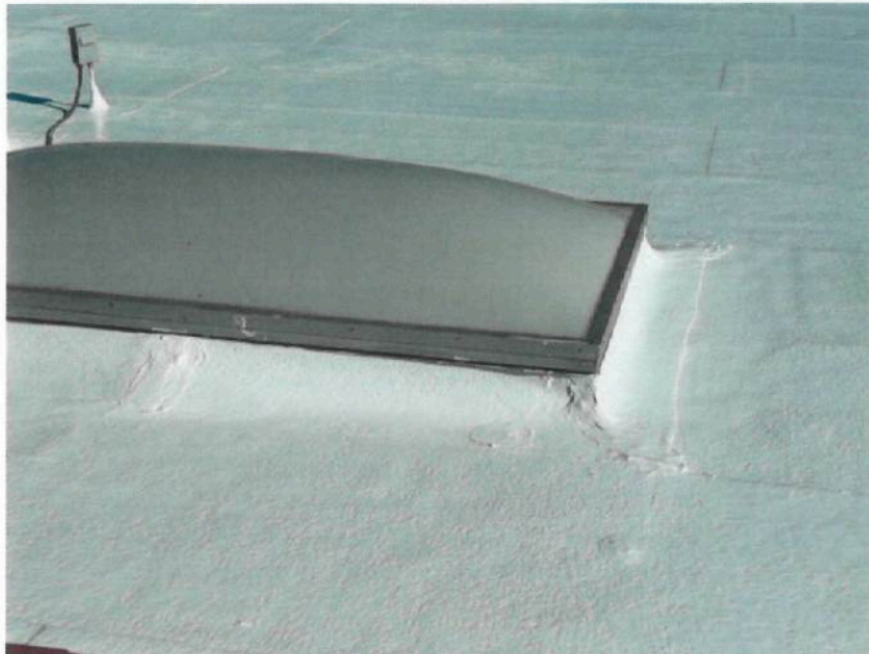
All skylights are sealed properly.

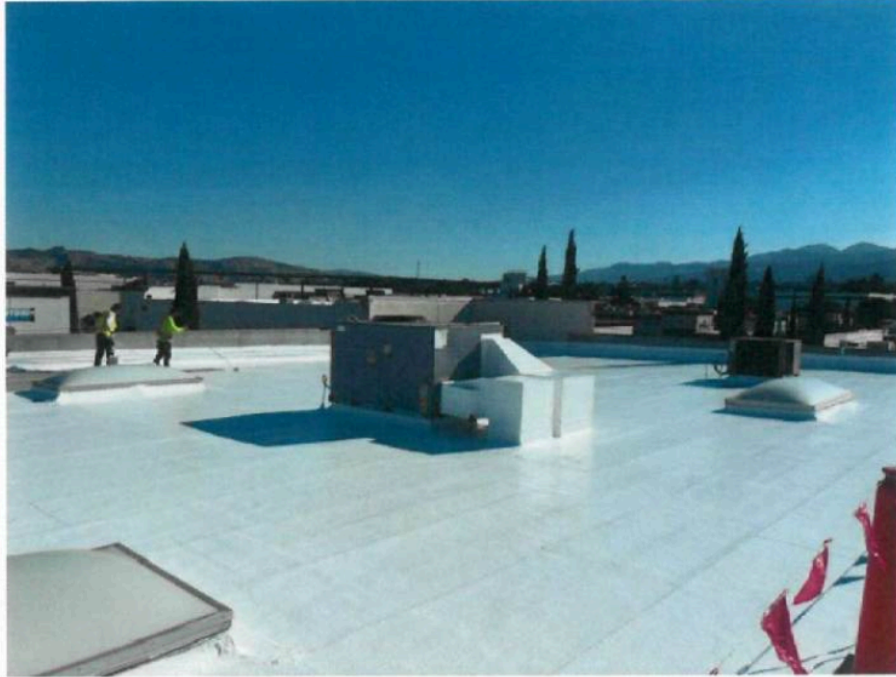
All duct work has been cleaned, primed sealed and coated.

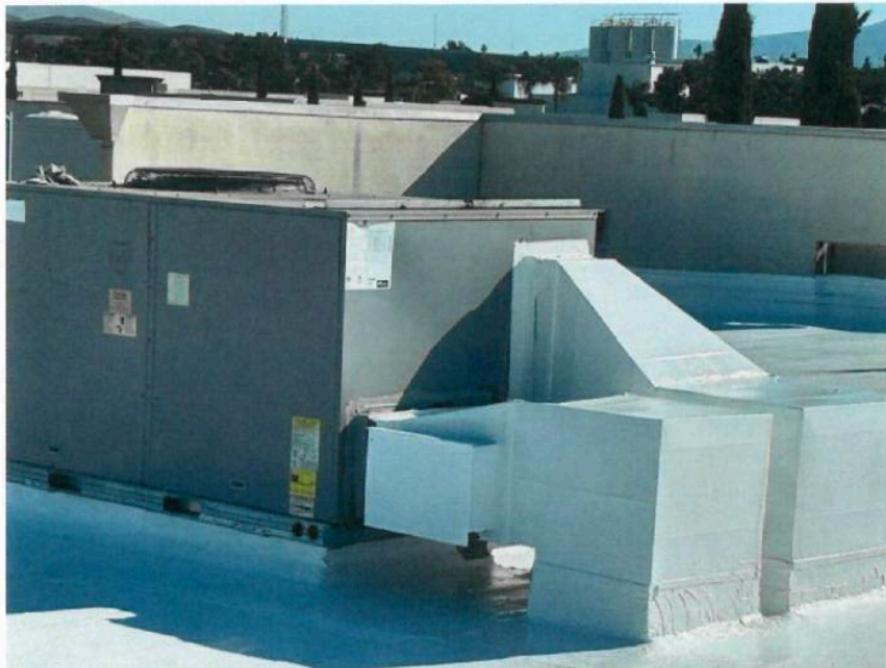
Duct work has been properly sealed.

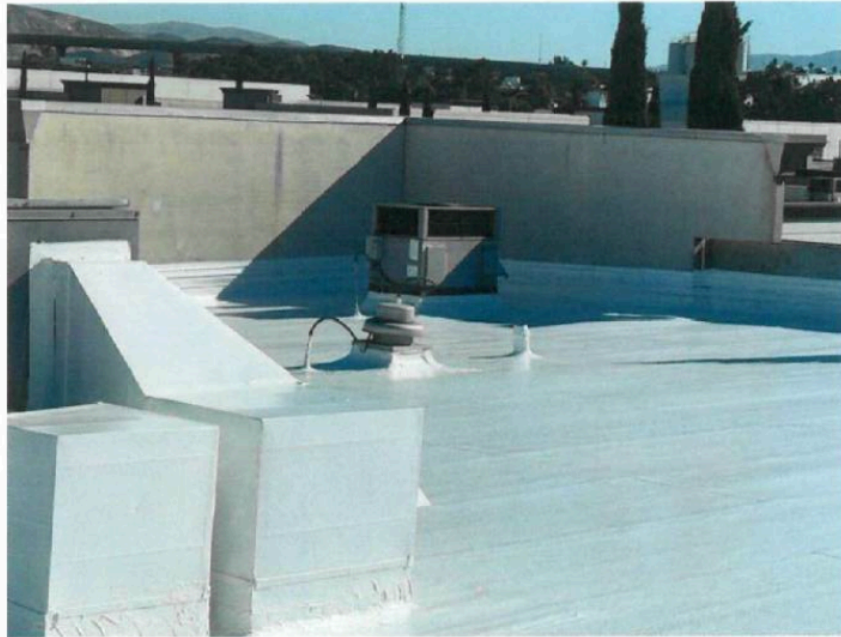
All through roof penetrations have been properly sealed and coated.

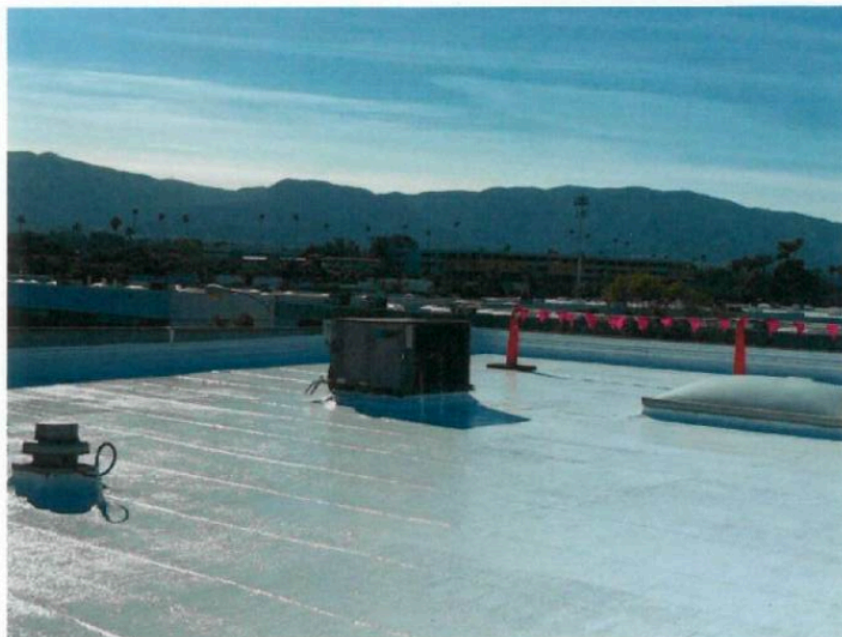
Silicone coating has been applied over this area at a rate of three gallons per every 100 square feet.

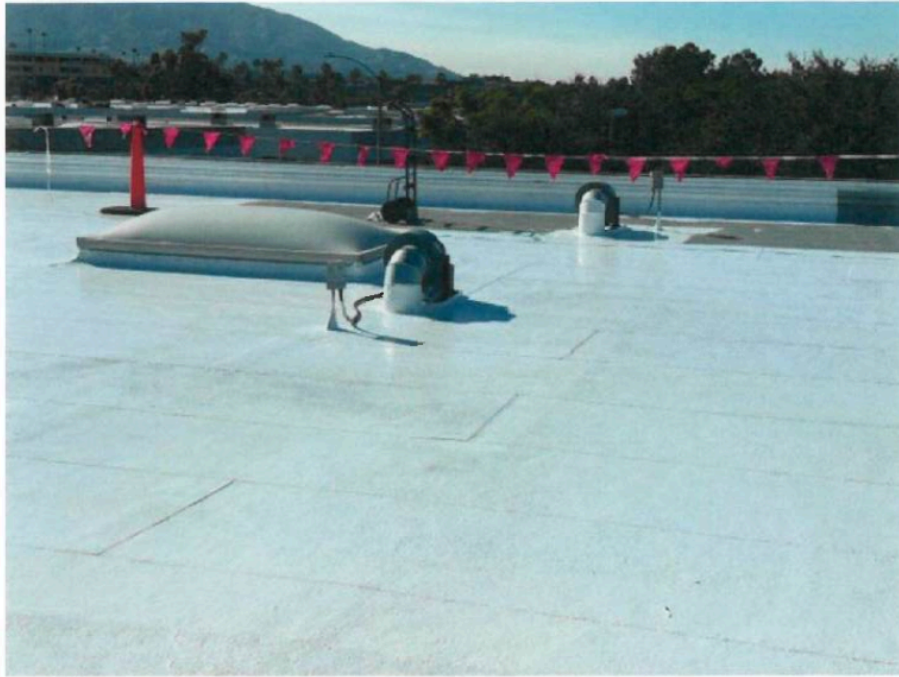
Coating the existing roof system with Silicone.

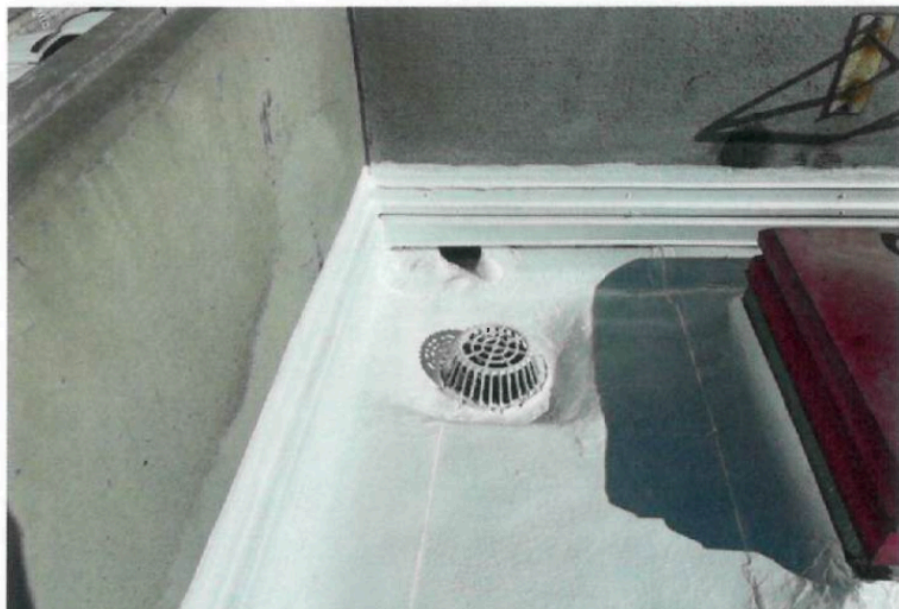
All drains and through wall scuppers have been properly sealed and coated.

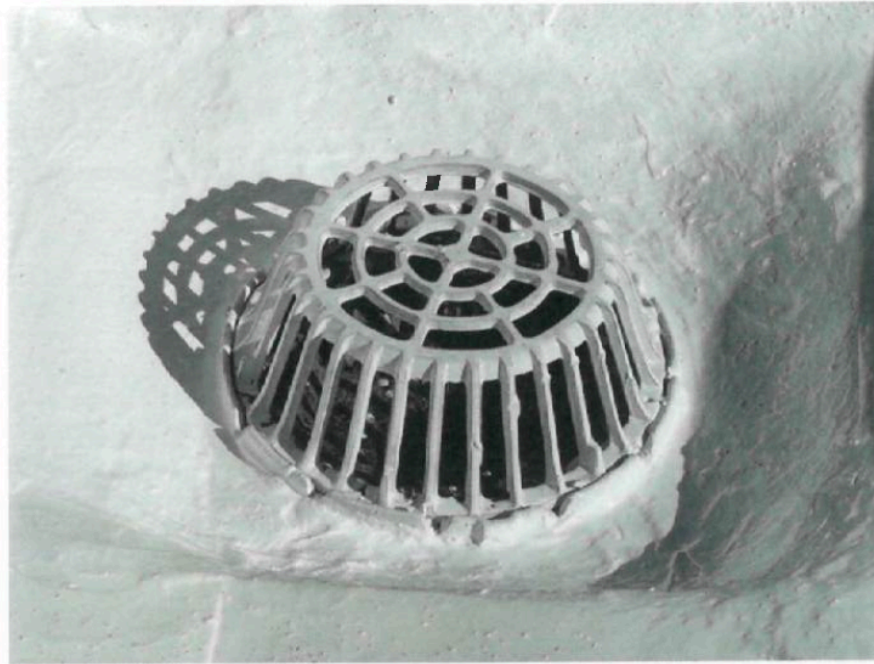
Drains have been reinforced using Silicone mastic and then coated.

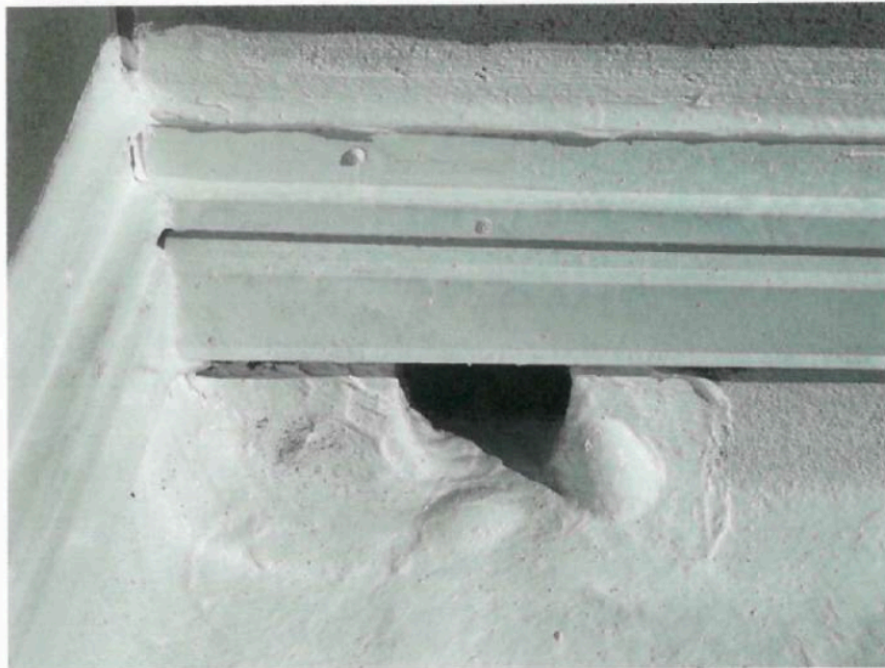
Scupper drains have been sealed and coated.

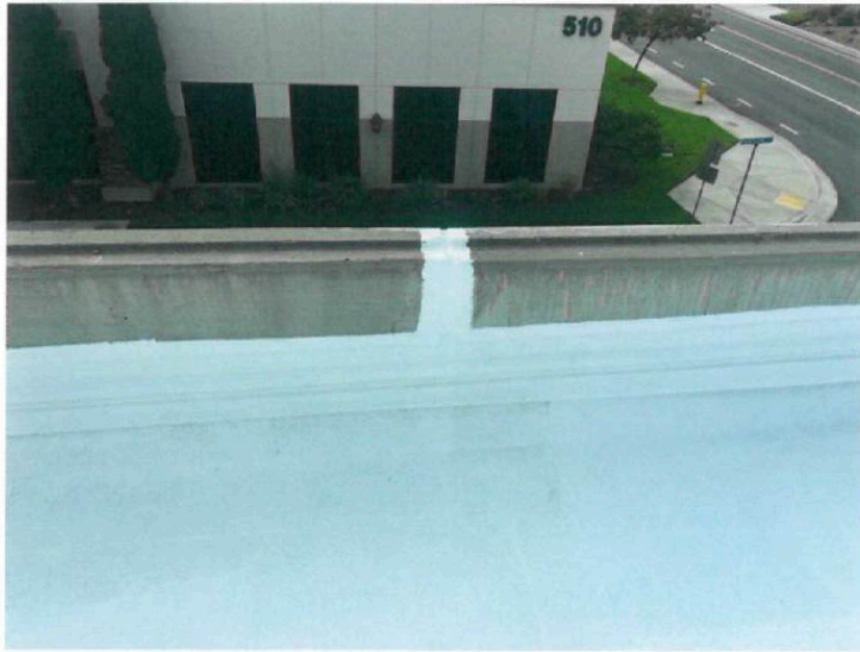
All expansion joints at the parapet walls have been reinforced  
with Silicone mastic and coated.

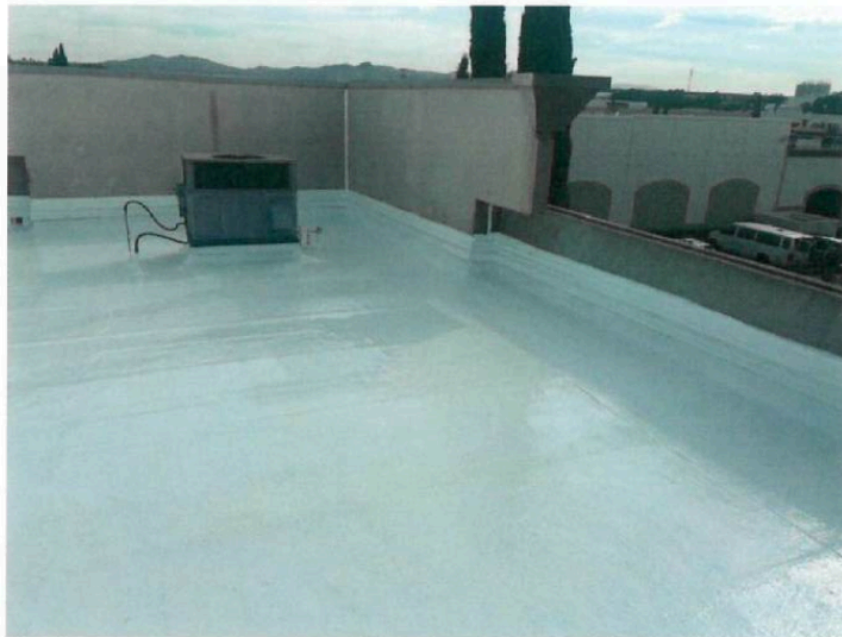
Completed Silicone roof system.

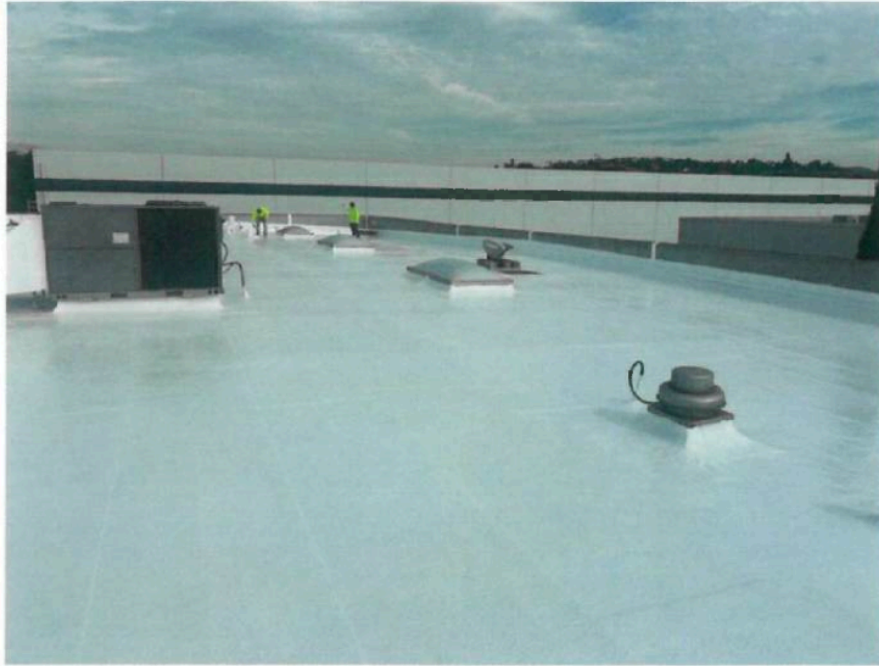
Completed Silicone roof system.

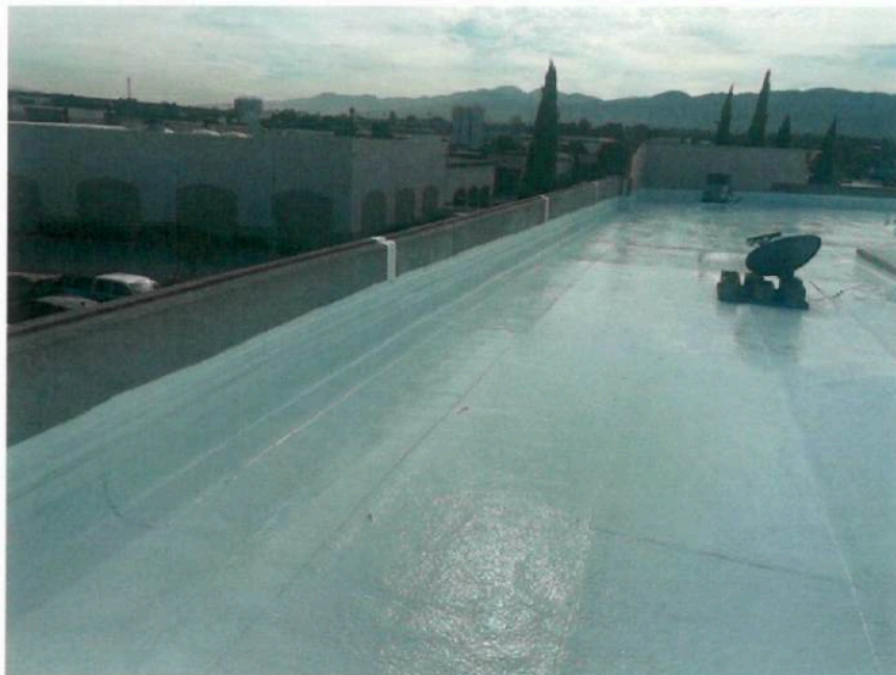
Completed Silicone roof system.

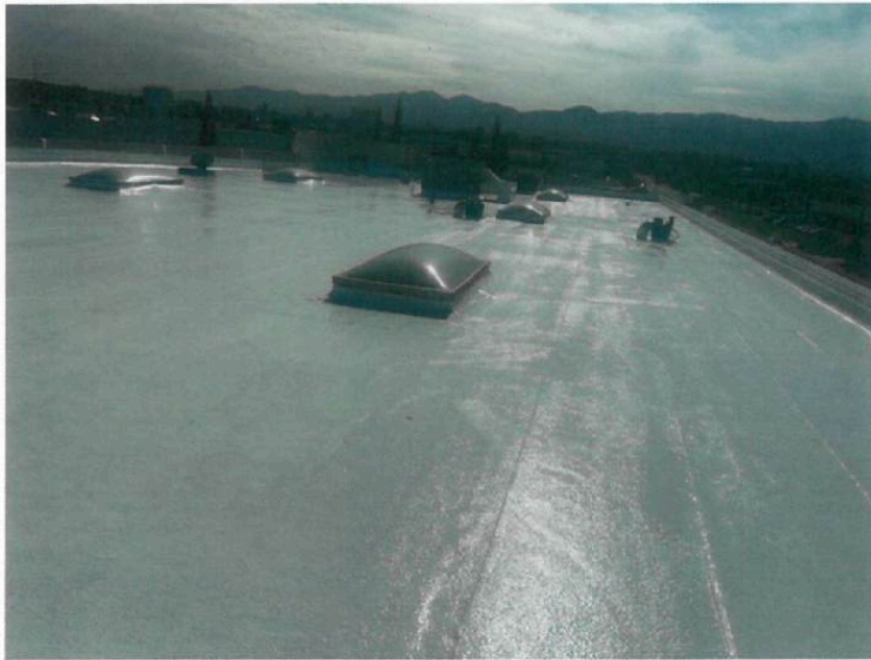
Completed Silicone roof system.

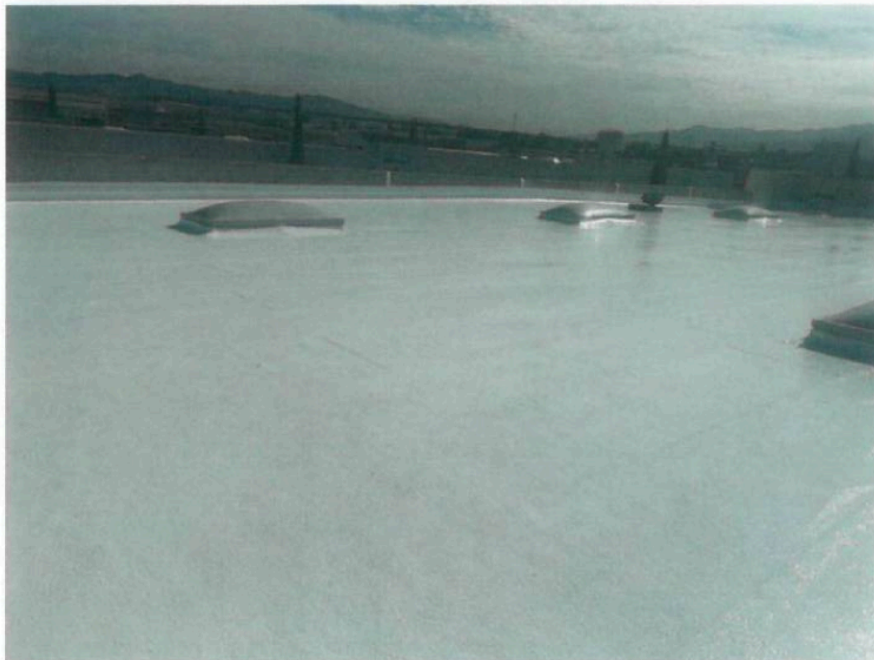
Completed Silicone roof system.
